# **Bristol Beacon**

Post Occupancy Evaluation Report

February 2025

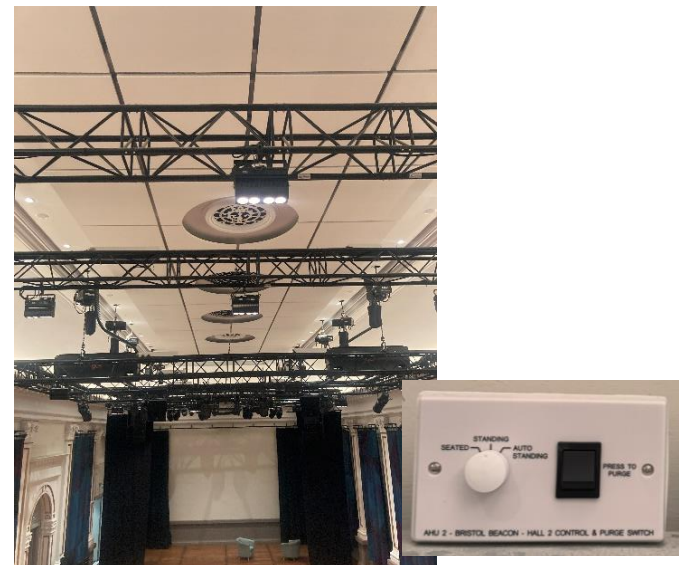
Hall 1 is mechanically ventilated, utilising a displacement strategy whereby the tempered supply air is provided at low level, utilising the voids below the raked seating used as plenums and extracted at high level above the stage.

Generally, for shows, keep the controls set in ‘Auto Standing’ so that they ramp up and down automatically helping to save energy whilst ensuring optimal space conditions are achieved. Avoid using the ‘Standing’ setting where possible as this will use the most energy. Note that the AHU was in standing mode during the site visit walkaround.

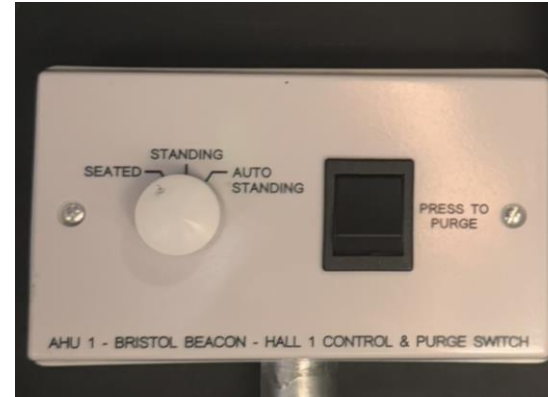
Hall 1 (AHU 01A & 01B) Fan Speed Controls.

- The brief asks for a standing capacity of 2,174 people. It was noted in the brief that the fresh air would be designed on the basis of 10l/s/p, with a purge and cooling rate of 16l/s/p. This equates to 21,740 (21.73 m<sup>3</sup>/s) – 34,780 l/s (34.78 m<sup>3</sup>/s)
- Within the des ops / as built drawings the fan speeds are adjusted through a three-position switch for Seated (10.89 m<sup>3</sup>/s), Auto Standing (10.89 – 13.2 m<sup>3</sup>/s), Standing (13.2 m<sup>3</sup>/s), as well as a switch to Purge.
- It's worth noting that the brief does not align with the as built information. There are many reasons why this difference has occurred, included spatial and acoustic issues.
- In Auto Standing, fan speed modulates to maintain CO<sub>2</sub> levels below 1000ppm, monitored by a duct-mounted CO<sub>2</sub> sensor, and/or follows the time schedule on the BMS.

It is not clear whether when in 'seated mode' the AHUs are controlled on temperature and CO<sub>2</sub>. If this is the case, the fans should ramp down to a minimum. However, the minimum speed will still be relatively energy intensive (~30% of the peak design rate).

It would be recommended to generally keep the AHU off for as much time as possible to save energy and only turn it on when a show is happening.

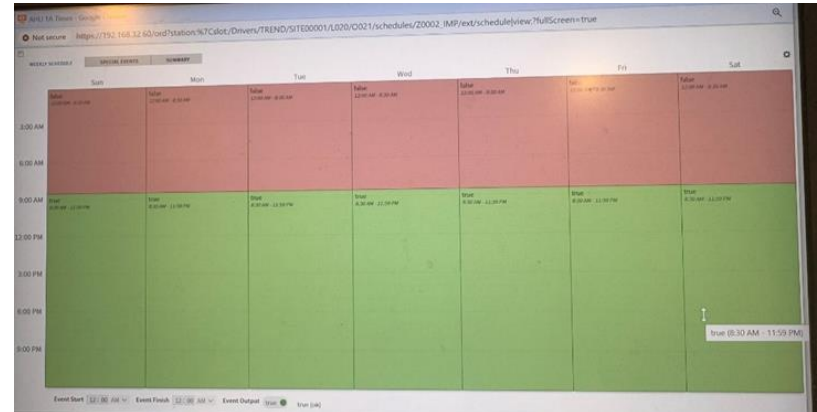
It is understood from the heating schematic that there are also radiators in the space. These were not observed during the site visit. These could be used for space heating, rather than relying on the AHU to provide heat however there is no central control of these. A general recommendation is to look at some zone control of the heating system which is mentioned elsewhere in the report (See Section 5.10).

A button could be added to the manual control to switch it on/off, rather than relying on the time schedule. Otherwise keep the time schedule off when a show isn't happening.

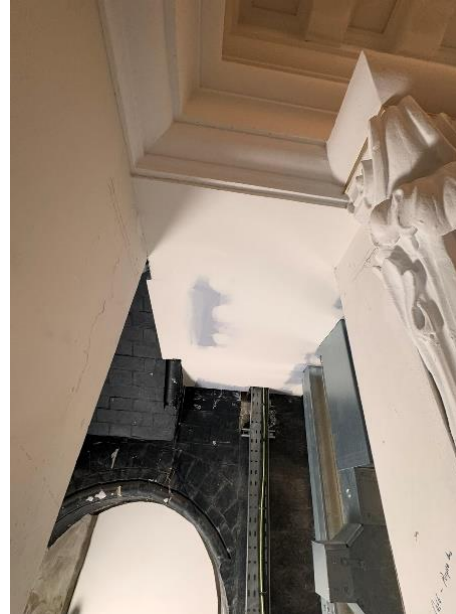
There was also a noticeable pressure difference when opening the doors. This suggests that there is a pressure imbalance in the air handling unit which is causing a negative pressure created through higher extract flow rates compared to supply. This is sucking in air from the outside through gaps in the fabric causing draughts and excess cold air.

The commissioning certificates should be reviewed and testing carried out to ensure balanced airflows of the supply and extract at the different control settings. This may require an inspection and testing of the Volume Control Dampers (VCDs) (highlighted in yellow. Access could be difficult.

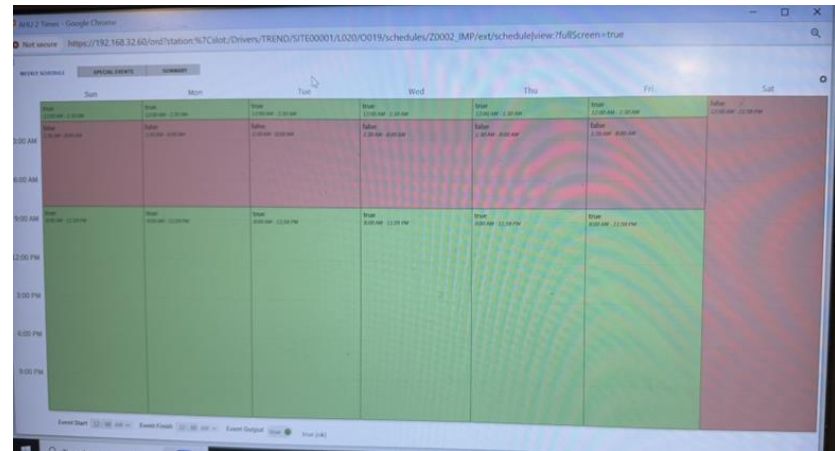
Intake temperature reading appears high compared to the outdoor temperature (17.4°C compared to 9.6°C at the time). It is suggested to check this sensor is reading correctly as it might be impacting the AHU's control of the thermal wheel to provide heat exchange, leading to more gas consumption.

As with Hall 1 it would be recommended to generally keep the AHU off for as much time as possible to save energy and only turn it on when a show is happening. As with Hall 1 the AHU running will use a lot of energy.

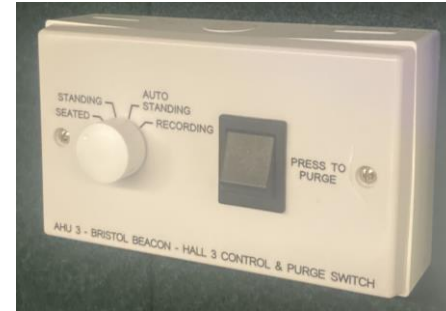
Hall 3 (AHU 03) Fan Speed Controls

Hall 3 is served by a dedicated variable-speed air handling unit (AHU 03) with recirculation, heat recovery and free-cooling capability to meet the ventilation, temperature and acoustic criteria.

The time schedule might have the potential to be reduced down to help reduce energy consumption as generally spaces connected to this AHU might not need to be operational during the day.

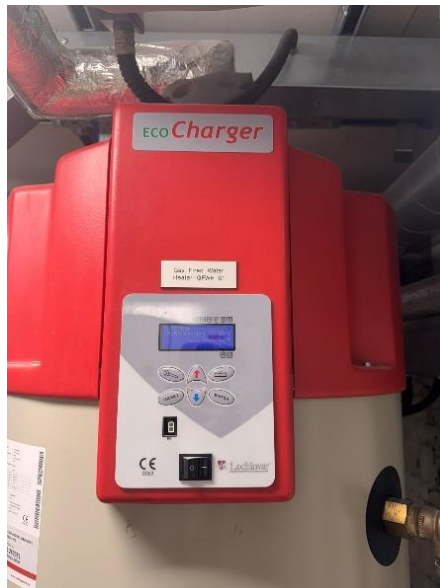
The heating and hot water seems to be controlled on the same LTHW time schedule as the heating, however this requires further investigation. The system is currently running 24/7, which could be reviewed and reduced to when the building is open and there is a hot water demand. This might be possible via on the onboard controls of the water heaters. This will help save energy by reducing pumping energy and hot water pipework losses so decrease the gas consumption.

The return water temperature should be around 55°C when in operation. The graph demonstrates that the return temperature is generally above this suggesting that the water flow setpoint could be reduced. This will help reduce system heat losses and reduce gas consumption.

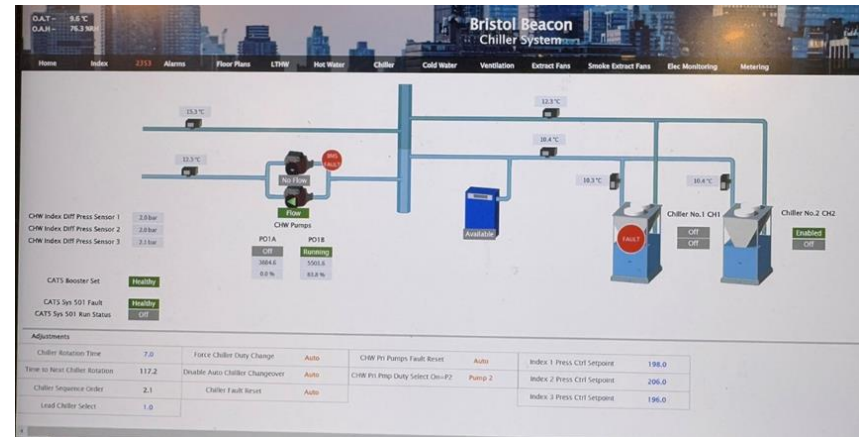
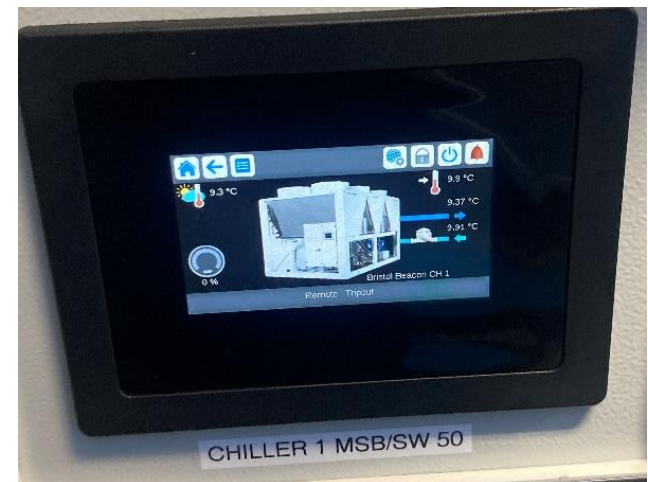
Cooling water for the AHUs and fan coil units is generated by two air-cooled chillers at level 7 in the plant tower above the “get in” yard.

There is a fault with chiller 1 according to the BMS and a BMS fault with one of the CHW pumps. Both require investigating. However, it appeared from the on-board controller on chiller 1 that it was working, so the fault could be due to the BMS communications.
